Environmental DNA (eDNA) Survey for Platypus Across Ipswich

2022

Prepared for:

Jack McCann
Waterway Health Officer (Infrastructure and Environment Department)
Ipswich City Council
(07) 3810 6975

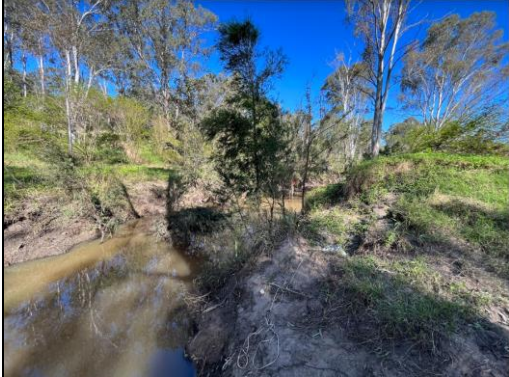
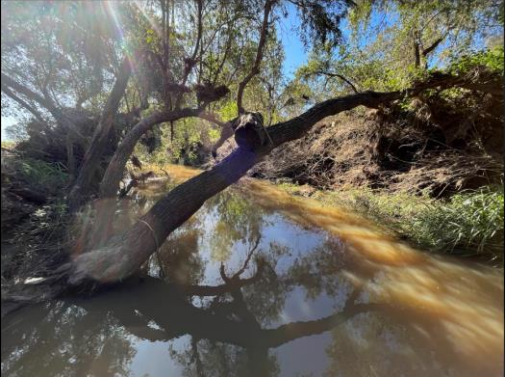
Platypus detected site	Feature	Assess		
BUND04 & BUND08	Banks – sandy Overhanging vegetation	Erosion

A number of sample sites were noted to have significant damage resulting from for the two flood events (Table 4). These include sites where platypuses have and have not been detected. Where feasible, Ipswich Council could prioritise restoration activities that target improving platypus habitat.

Platypus detected site	Feature	Assess
BUND04 & BUND08	Banks – sandy Overhanging vegetation	Erosion
Opossum Creek all sites OPOSS01 – Creekside Park	Banks and connectivity under causeway	Erosion and disturbance due to pipeline upgrade
WOOD01 & WOOG02	Banks - sandy	Erosion
WOOG03	Eugene Street reserve pool	Pool depth
Platypus not detected		
BREM01	Banks and native vegetation	Erosion
PURGA02	Banks – sandy Overhanging vegetation	Erosion

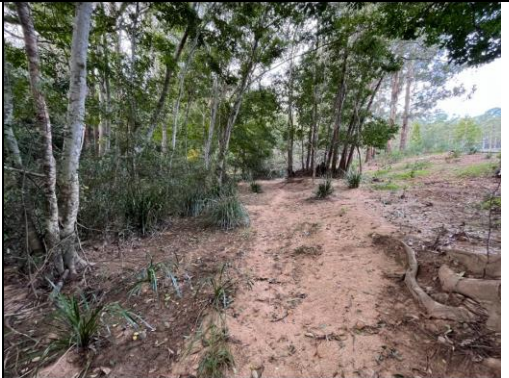
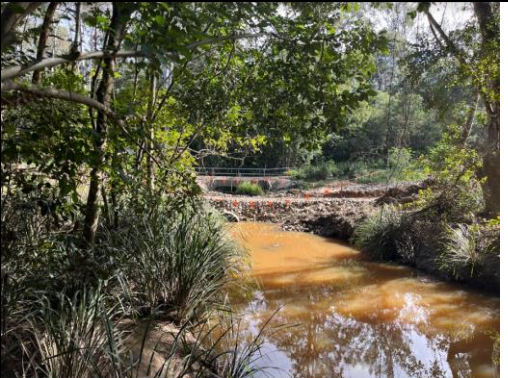
Opossum Creek all sites OPOSS01 – Creekside Park	Banks and connectivity under causeway	Erosion and disturbance due to pipeline upgrade

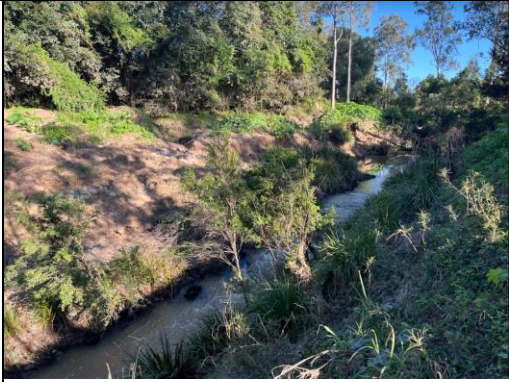
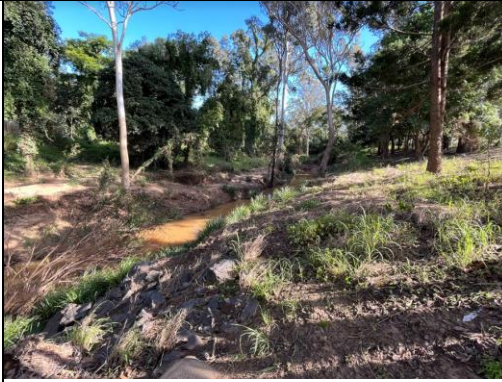
WOOG01 & WOOG02	Banks - sandy	Erosion

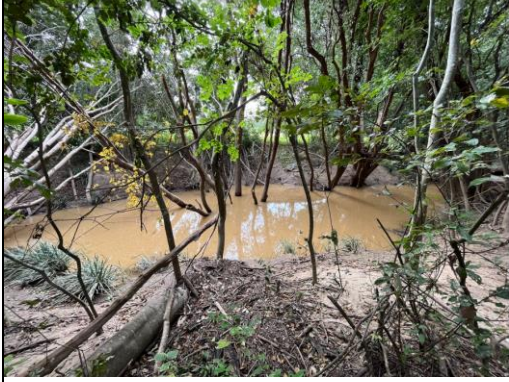
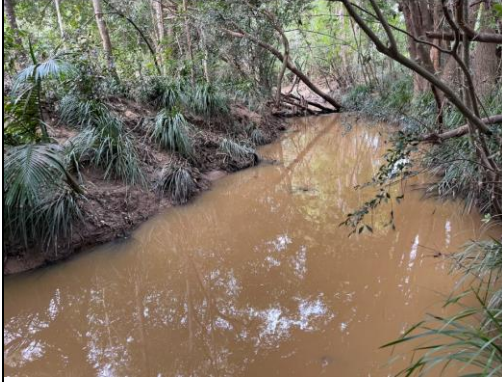
WOOG03	Eugene Street reserve pool	Pool depth

A particular site in Woogaroo Creek, at Eugene St Reserve contains a pool of water that has shown to be important for platypuses' inhabitation in the catchment. Wildlife Queensland recommends further inspection of this pool to determine what impact the two floods have had on the size and depth of the pool. Possible restoration actions include bank stabilisation and revegetation and dredging/excavation of the pool if necessary (note, such an activity would require guidance by subject matter professionals). Mapping, measuring and monitoring other pools/waterholes in the catchments would also benefit the knowledge base around refuge pools for platypus populations in the region.

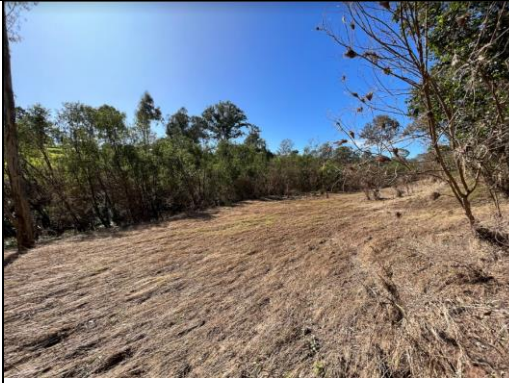
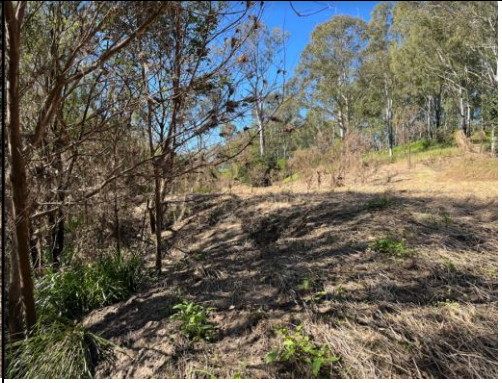
Platypus not detected				
BREM01	Banks	Erosion
